# Power quality measurement campaign at a Jordan LV grid and determination of the influence of a large PV plant

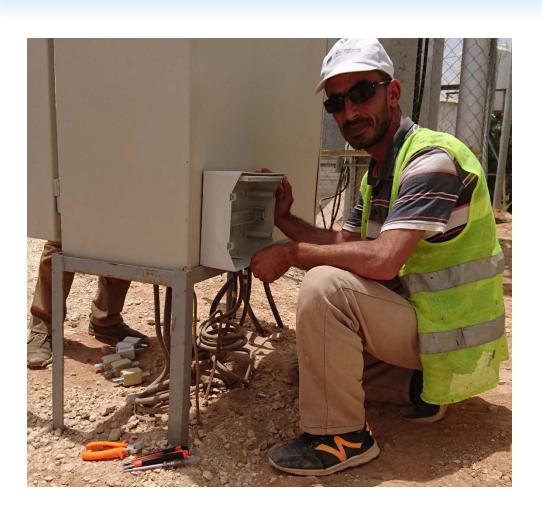
# Local electrician supporting us with the installation

- There were concernes, that the devices might overheat
- PQA is anstalled at north side of busbar housing in as shady place as possible
- No problems with heat observed so far

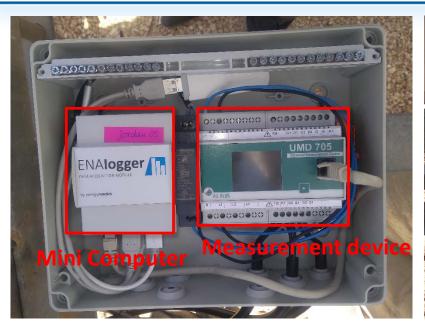
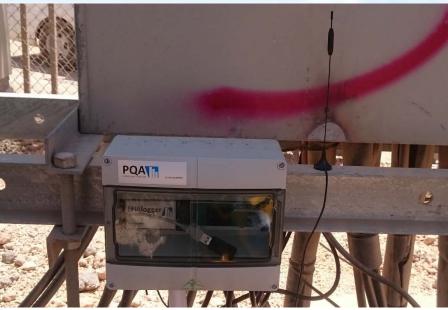
#### Measurement setup

- Mini computer is used for
  - Internet connection for monitoring and data transfer via secure VPN tunnel
  - Backup data storage on USB stick
- In-house development by Energynautics

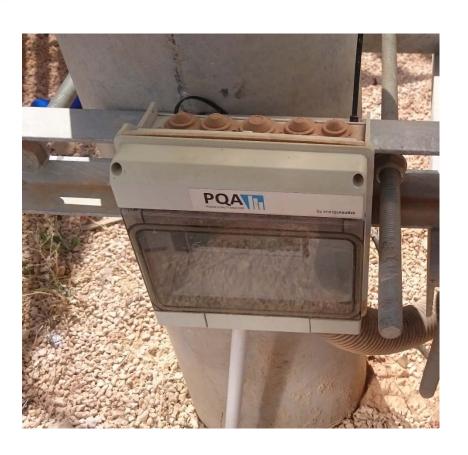
#### Measurement device after 1 year

- Huge amounts of dust
- Bird excrements on some housings

- Good housing is essential!
- > IP 65 is recommended

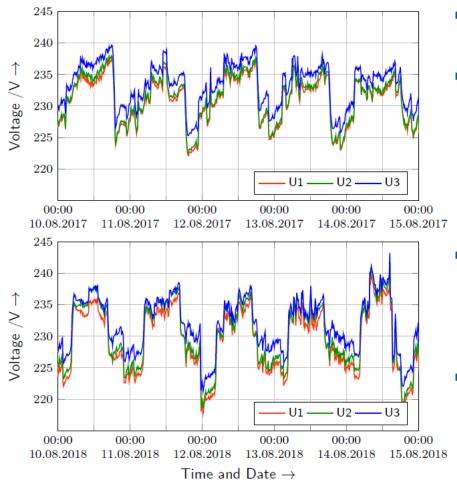
#### Voltage magnitude:

- Voltages fluctuates a lot
- Voltage is higher during the day even before connection of PV plant
  - Influence of the load of the camp
- Increased supply duration in 2018
  - Longer periods of low voltage
- Requirements of EN 50160 (+/-10 % for 95% of the time) fulfilled

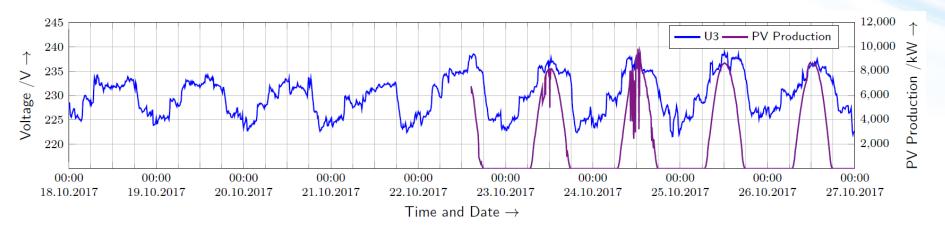
#### Voltage magnitude:

- Voltage immediately rises by ca. 4V at the moment the PV plant is connected
- Higher magnitudes in the days after connection
- Complaints by consumers about overvoltages in the LV grid
  - Operation mode was changed to cosphi = 0.9

- Power Quality has been measured in a LV grid in Jordan to determine the influence of a large PV plant on power quality in that grid
- It was observed that the PV plant lifts the voltage, when dispatching power
  - Operation at power cosphi = 0.9 inductive compensates the voltage increase
- There was no influence of the PV plant on THD, flickers or unbalances observed

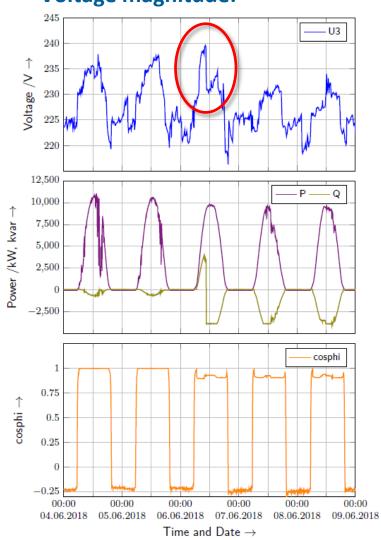
#### Voltage magnitude:

- Accidently, PV plant first operated overexcited instead of underexcited
  - Extra high voltage peak
- When the mistake was corrected voltage immediately dropped by approximately 8 V
  - Controlling voltage with reactive power is certainly effective
  - Disadvantage: less active power is dispatched due to inverter current limits

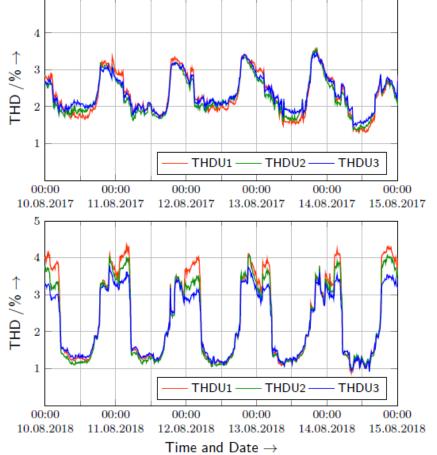
#### **Total harmonic distortion (THD)**

- Higher THD during the night than during the day
  - Probably due to many LED lamps in the camp, which have high harmonic emissions
- No influence of the PV plant is observed
- Requirement of EN 50160 (THD below 8% for 95% of the time) fulfilled

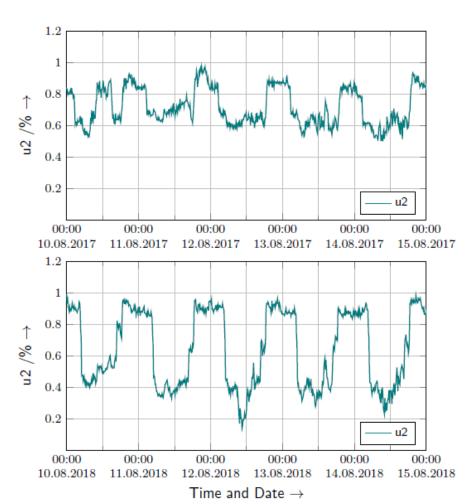
#### **Unbalances**

- Higher unbalances during the night than during the day
  - Correlation with power supply of the camp is likely
- No influence of the PV plant is observed
- Requirement of EN 50160 (unbalance below 2% for 95% of the time) fulfilled

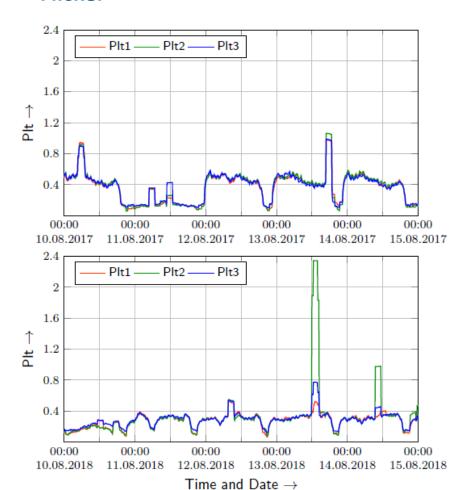
#### **Flicker**

- There seems to be a periodic behavior, but not as clear as for the other quantities
- No influence of the PV plant is observed
- Requirement of EN 50160 (flicker below 1 for 95% of the time) fulfilled
